Manhole Inspection Summary

Manhole # S25C__044MH

Insp Date: **12/4/07 12:23 PM**

Location Address: **1029 BENNETT PL**

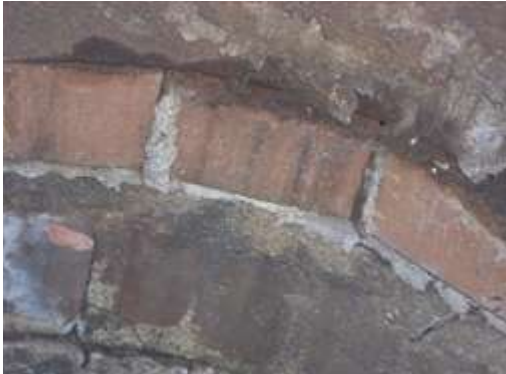
Defect 2

Condition: ☐ Sound ☒ **Cracked** ☐ Root Intrusion ☐ Loose Brick ☐ Deteriorated

CORBEL CRACK (LOWER LEFT)

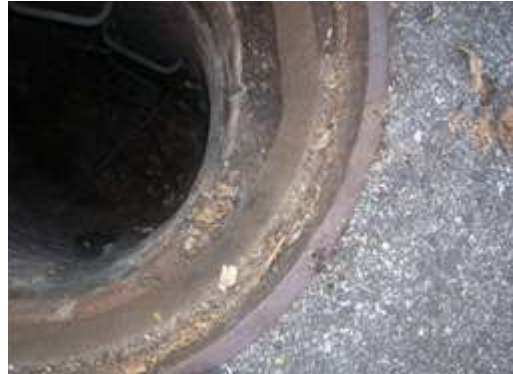
Defect 1

Offset: **2** (in.)

FAME OFFSET

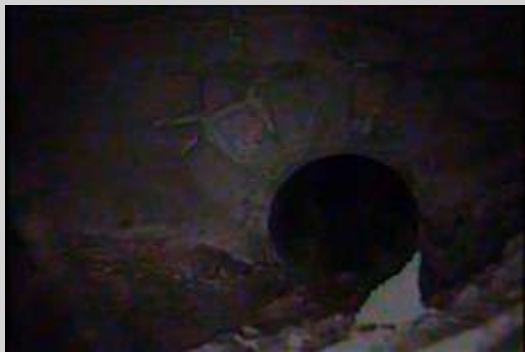
12 O'Clock Outflow

8 in. Circular Gravity Sewer
Pipe Out @ 12 O'Clock

Deposits: ☐ None ☐ Mud ☐ Sludge ☒ **Debris** ☐ Grease

Silt Depth: **1** (in.) Deposits Extent: **Light**
